## Study of Tube And Tank Specimens Repaired Using a Carbon Fibre Reinforced Epoxy

### Abstract

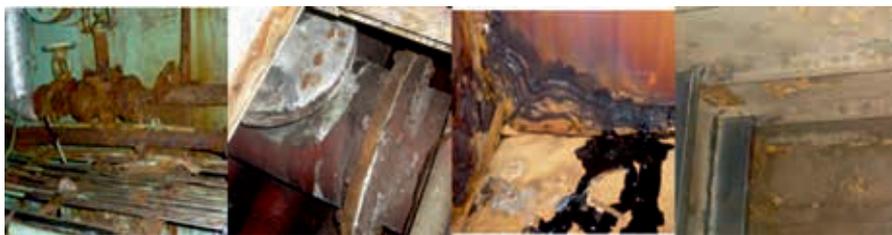
Merchant and passenger vessels, such as tankers or bulk carriers, operate in harsh environments, enduring corrosion and cyclic force and thermal loads that lead to various forms of vessel damage and defects as presented in Figure 1, endangering people and cargo, as well as posing a risk to the environment in some cases.

*Figure 1: Frequent problems of corrosion and cracks on various positions on different vessels*

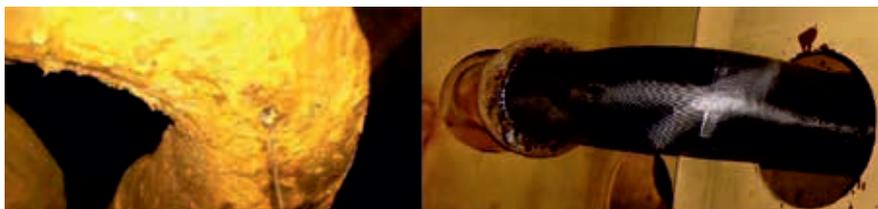
*Figure 2: Steel tube before (left) and after the repair (right)*
